BOULDER PUBLIC LIBRARY

UPDATED FACILITIES SUSTAINABILITY STUDY | MAIN BUILDING

studiotrope
design collective
12|02|15

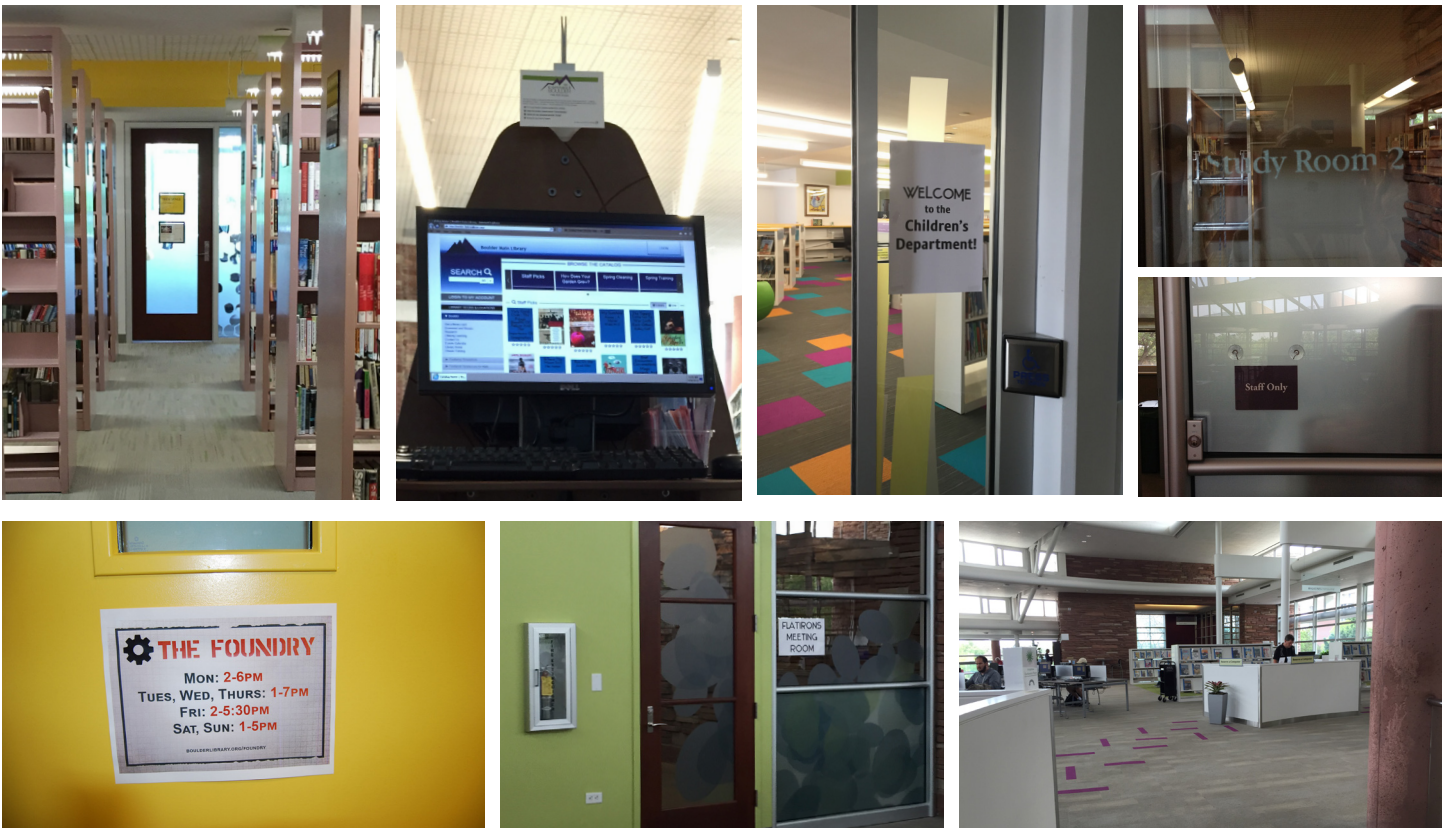
CONCERN: TEMPORARY AND LEGACY SIGNAGE
As each construction phase (4 in total) was completed, temporary signage was installed to identify newly named destinations and provide information. Compounding this is legacy signage that fell outside the renovation scope. (see below)

RECOMMENDATION: SIGNAGE AUDIT AND GUIDELINES
Now that all phases of the renovation are complete, and both staff and community have become acquainted with the enhanced building. A signage audit is recommended to evaluate what permanent signage is necessary and incorporate it into the newly established wayfinding language. This signage audit may address the Main Library as a standalone facility, or be completed system wide to address signage issues at all library facilities.

In either case, it is recommended that a BPL representative work with a graphic designer to conduct a Signage Audit and establish Signage Guidelines.

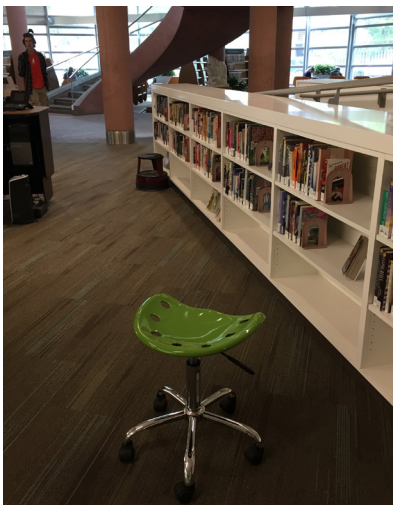
CONCERN: COLLECTIONS NEAR THE FLOOR
The lower shelving at Fiction and New Fiction on Level 1 of the south wing is proving problematic for physically challenged patrons.

Area to have additional stools.

It is also recommended that 2-5 stools be provided at the built-in book shelves along the ramp. These stools should have the following characteristics: a low seat height (optimal height to be determined); are backless, without wheels and light weight; and optional handles or space to place books.

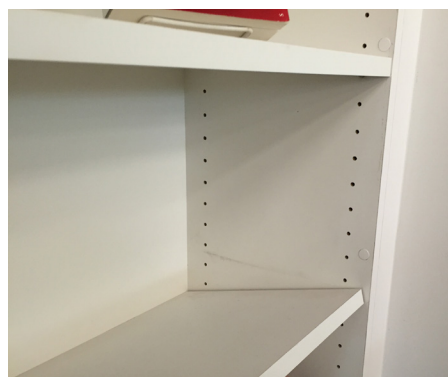
Slope shelf to allow books to slope upward.

It is also recommended that the built-in book shelves along the ramp, be tilted so the front face is 2 pegs higher than the back. This, along with installing a 6.5" deep shim, will push the books towards the front of shelves and enhance visibility.

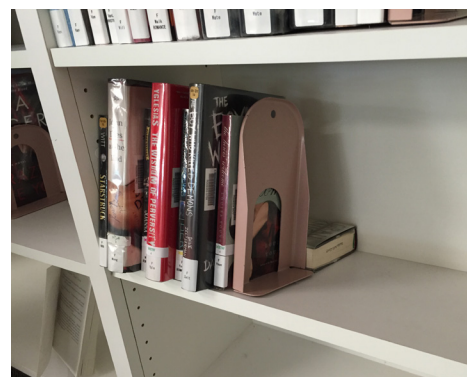
Move books to front face of shelf.

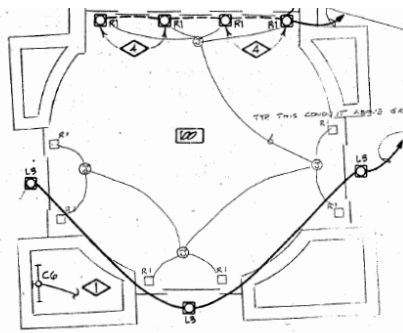
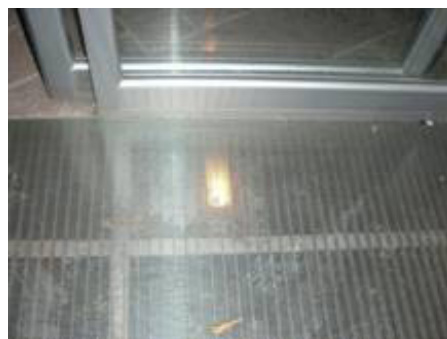
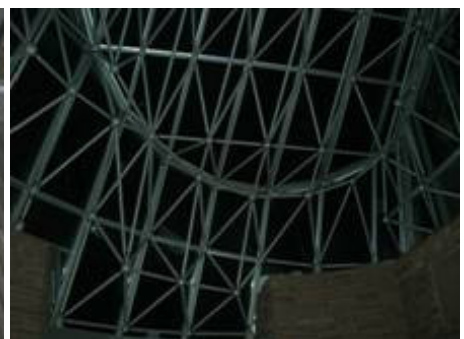
LIGHTING UPGRADES FOR ENTRY CONOID

CONCERN: The lighting in this area is accomplished through the use of either floor mounted or under grate mounted uplights, in addition to uplights mounted on the ledge between the rock wall and the windows. The indirect lighting scheme does not work well in this space since most of the lighting is reflected against either surfaces with a low reflectance (rock walls) or surfaces with a very high transmittance (windows).

RECOMMENDATION: Increasing the lighting in this entry point will make the library a much more inviting space to the public at night. The addition of some type of overhead lighting, which provides downlighting in the space, is recommended. The use of pendant mounted decorative cylinder type lights would be very functional in this space. Another option would be the use of pendant mounted glowing “sticks” of light, which play off of the structure in the rotunda.

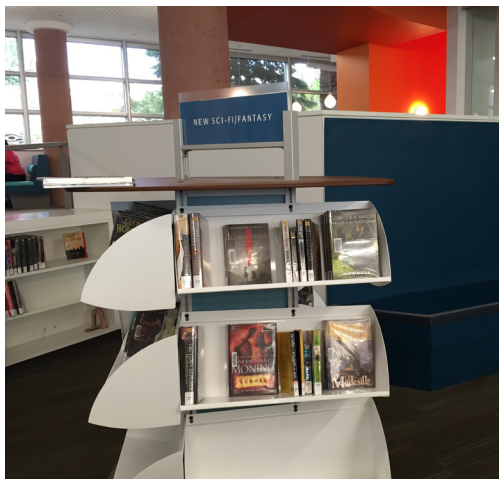
Jelly Drops

Consider removing 3 high shelving units at level 1 Fiction and replacing with the same mobile material displays found elsewhere in the library (jelly drops) for **HIGHER SHELF HEIGHT**. Shelving ranges could be relocated to the second level, replacing the existing shelving.

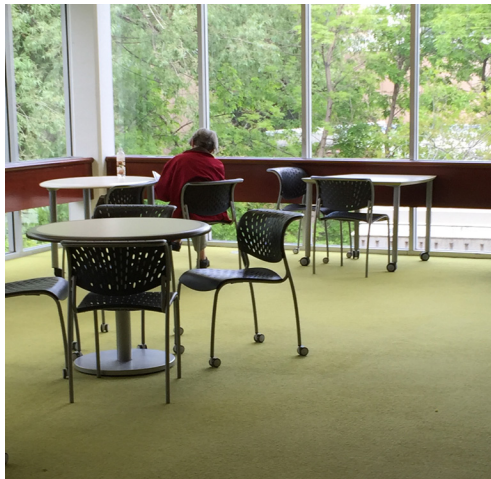
Existing chairs with casters

As **CHAIRS** are replaced consider chairs **WITHOUT CASTERS**

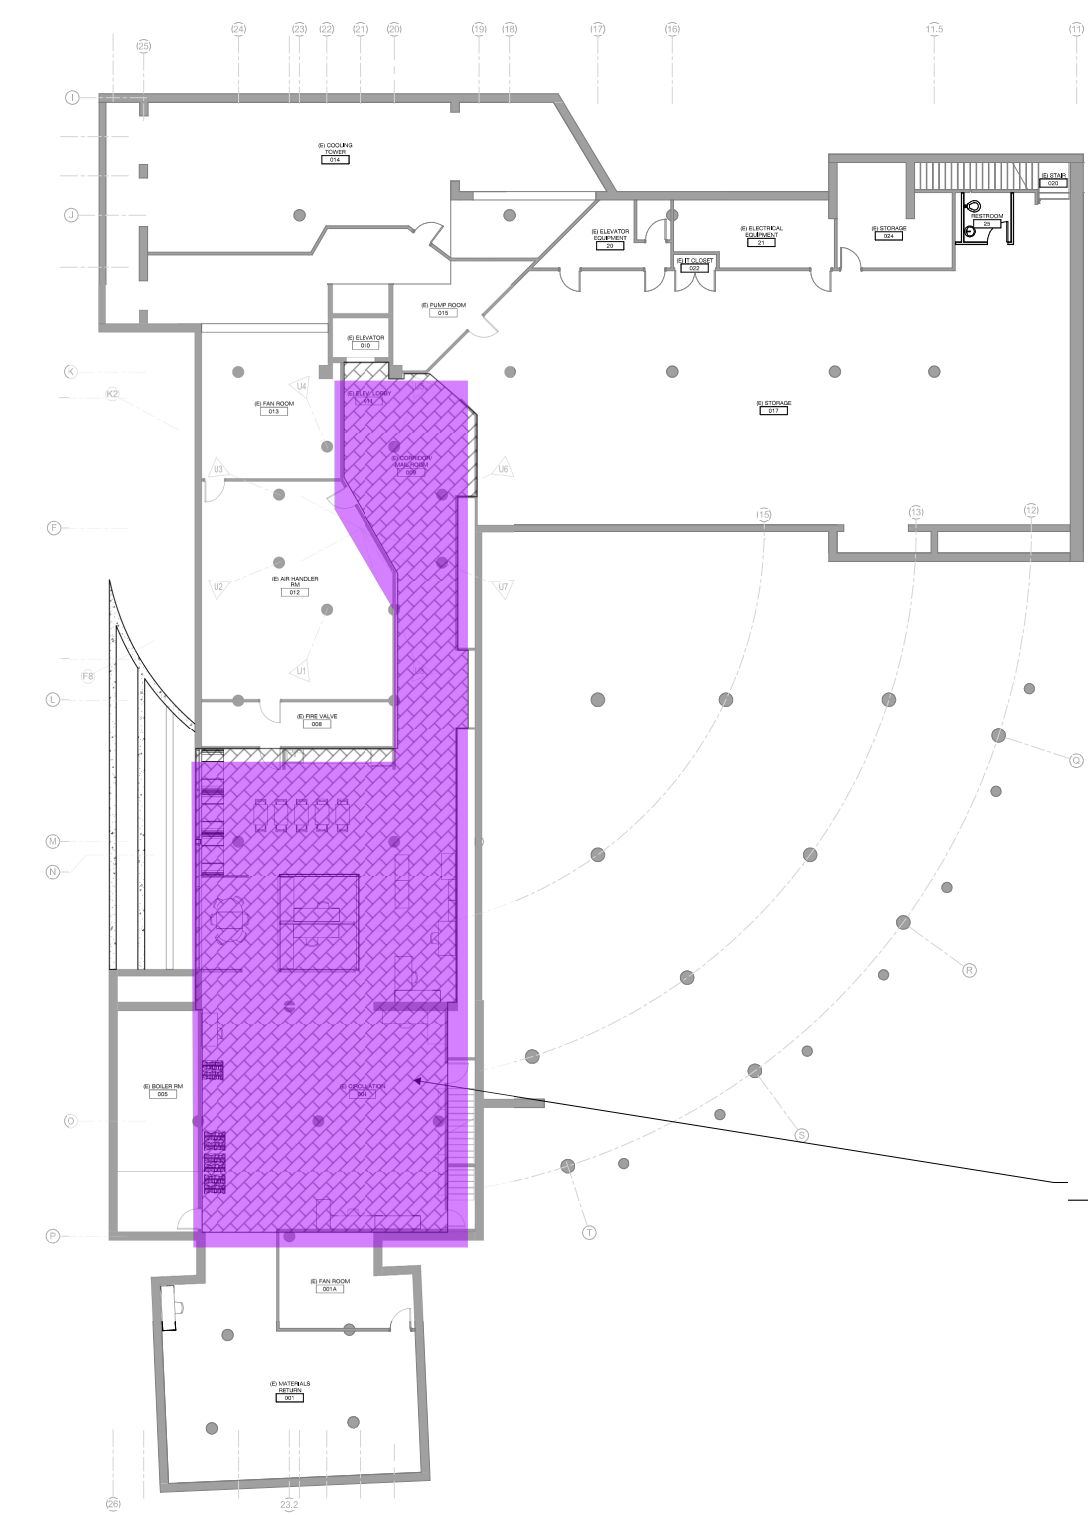
Lower Level Office Area: FEASIBILITY

Existing Conditions: The lower level is divided into office space which also houses the book sorter and back of house storage, mechanical and electrical spaces. The back of house storage, mechanical, and electrical spaces are currently illuminated with surface or pendant mounted strip lights. These lights do an adequate job of illuminating these spaces and we do not recommend replacement, unless the function of one of these spaces changes. The office spaces are illuminated with 3-lamp, T8, 2x4 recessed parabolic type luminaires. The directional nature of these luminaires in conjunction with a lower ceiling height makes this area feel dark to the users.

Energy Code Implications: The new lighting does not have to comply with the requirement of 70-percent below the value defined in the 2012 IECC if we are modifying less than 50-percent of the installed lighting and the overall lighting power density is reduced. If more than 50-percent of the lighting in this space is replaced, then all new lighting, when combined with all existing lighting to remain in this area must have a power density (watts per square-foot) of less than 70-percent of the values defined in the 2012 IECC. The lighting controls within the space will also have to be brought up to the requirements of the 2012 IECC.

Recommendations: It is recommended that a one-for-one replacement of the existing parabolic type luminaires with high efficiency 2-lamp, T8, 2x4 recessed volumetric type luminaires be completed. The increased efficiency of the volumetric type of luminaire as well as optics which allow a greater amount of light on both the walls and the ceilings make the space appear both larger and brighter. This lighting change results in a power density of 0.76W/ft². This complies with the City of Boulder energy codes for a library application. The recessed volumetric troffers would be similar to Neoray 284 series.

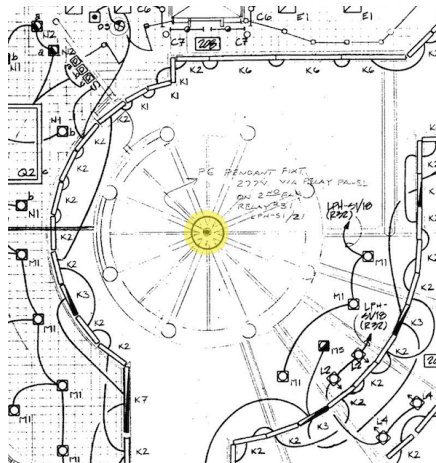
MAIN STAIRS TO SECOND FLOORS

CONCERN: The stairs are not a primary area of concern for the library, however the light levels are low for such a prominent architectural feature. Additionally, replacing the existing lamps in the lone pendant is difficult and requires scaffolding to be constructed. Most of the light from this pendant is directed towards the glass ceiling above the stairs, which does not reflect much light back into the space.

ENERGY CODE IMPLICATIONS: Any alteration to the stair lighting will involve more than 50-percent of the installed lighting the new lighting, when combined with all existing lighting to remain in this area must have a power density (watts per square-foot) of less than 70-percent of the values defined in the 2012 IECC. The lighting controls within the space will also have to be brought up to the requirements of the 2012 IECC. ASHRAE 90.1 lowers this threshold to 10-percent.

RECOMMENDATION: One option is to install an LED illuminated handrail, to better illuminate the stair treads. Also replacing the pendant with an LED decorative pendant mounted cylinder, or other type of Luminaire with a substantial down lighting component.

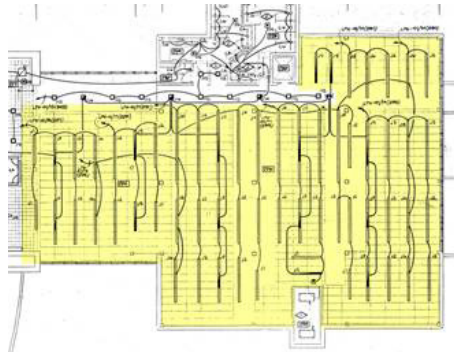
SECOND FLOOR STACK AREA: ADULT NON-FICTION SECOND FLOOR

CONCERN: This area is illuminated with a pendant mounted direct type of luminaire, with one row of lights in each isle. The illumination level is adequate in this space, however occupancy sensors have been installed in each row to individually turn on each row of lights only when people are present. This means that patrons could potentially walk into a very dark stack area. There is some night lighting in this area, but it is located between the stacks and not in the aisles.

ENERGY CODE IMPLICATIONS: ASHRAE 90.1 does not allow both relamping and re ballasting without compliance with the lighting power densities indicated in the code. Typically the cost to relamp and rebalast is not much less than providing new luminaires.

RECOMMENDATION: Lighting approach and controls shall be reevaluated based on final use of space, including collection type, size and shelving solution. At a minimum, it is recommended that the existing lights be rebalasted with dual level ballasts, allowing the lights to dim, but not turn off when there is no one in the area. This will greatly improve the impression of safety in the area. Unfortunately the cost associated with rebalasting and wiring the existing lighting is about 75% of the cost of purchasing new lights.

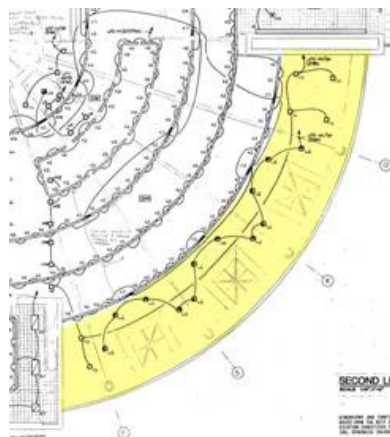
SECOND FLOOR: DOUBLE HEIGHT SPACE

- CONCERN:** This area has lower than recommended light levels. The lighting in this area consists primarily of large aperture, recessed, adjustable downlights, which are supplemented by a combination of floor and table mounted lamps. This area is also not helped by its proximity to the windows, which do not reflect much light back into the space.

- ENERGY CODE IMPLICATIONS:** Since this area is considered part of the Open Stack Area. The quantity of lighting to be changed is less than 50-percent of all of the lighting in this area, and therefore as long as the power density of the lighting is reduced, the power density of the entire area does not need to comply with the requirements of the 2012 IECC. ASHRAE 90.1 lowers this threshold to 10-percent, therefore making the modification of lighting in this area much more difficult to achieve without a major modification to the lighting in the open stack area.

- RECOMMENDATION:** Replace the existing downlights and supplement by either 2'x 2' or 1'x 1' recessed volumetric type troffers. This will increase not only the quantity of light in this area, but also the quantity.

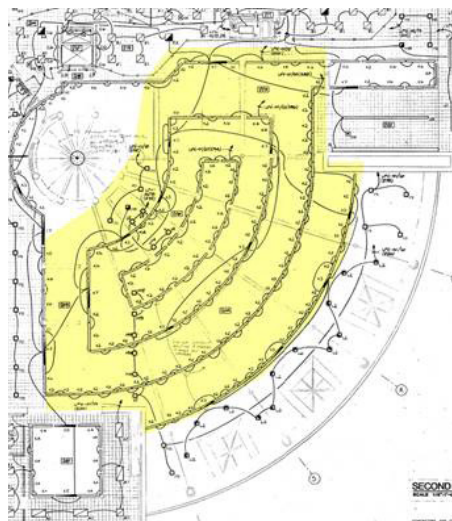
SECOND FLOOR: STACK AREA

CONCERN: This area is illuminated by the cove lights located at multiple levels around the space and are supplemented with stack mounted lights. Since the stack mounted lighting is manually turned on by the patrons and automatically turn off, these lights cannot be relied upon to contribute to the overall light level in the space. The height of this space along with the almost 100% indirect nature of the lighting contribute to lower than normal light levels. The existing drawings indicate that the existing cove lights utilize an asymmetric reflector to control the light.

It appears to have been installed as an industrial type striplight with a reflector which is less than ideal for this particular application. Additionally, dirt can reduce the light output levels.

ENERGY CODE IMPLICATIONS: Replacing the cove lights with new luminaires will not greatly improve the lighting power density in this space, and is therefore not a viable option. Since any replacement of the cove lighting will involve replacing more than 50-percent of the lighting in the space, then all new lighting, when combined with all existing lighting to remain in this area must have a power density (watts per square-foot) of less than 70-percent of the values defined in the 2012 IECC. ASHRAE 90.1 lowers this threshold to 10-percent. The lighting controls within the space will also have to be brought up to the requirements of the 2012 IECC. Bringing the existing lighting controls up to the 2012 IECC requirements will involve adding numerous lighting control zones in the existing space.

RECOMMENDATION: At a minimum, it is recommended that these luminaires be thoroughly cleaned to evaluate the increase in light levels in the space. And before determining a lighting approach, the existing cove conditions should be verified. If a cove light with an asymmetric reflector is not already installed, our recommendation is to replace the existing lighting with an asymmetric type of cove light. If a cove light is already installed and we have some leeway with the lighting power density supplemental lighting should be added to increase the light levels throughout the area.
